NDI No. Pa. - 231
HIGH POINT LAKE

PHASE I INSPECTION REPORT
NATIONAL DAM INSPECTION PROGRAM

High Point Lake Dam

13 October 1978

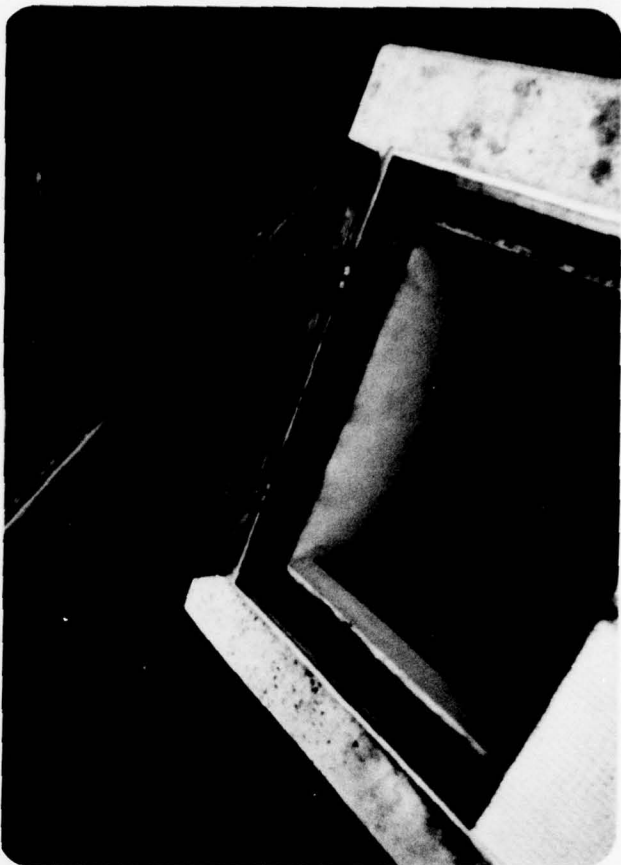
PHOTOGRAPH 8 Close-up view of the gate control located within the concrete riser on the upstream portion of High Point Lake Dam.

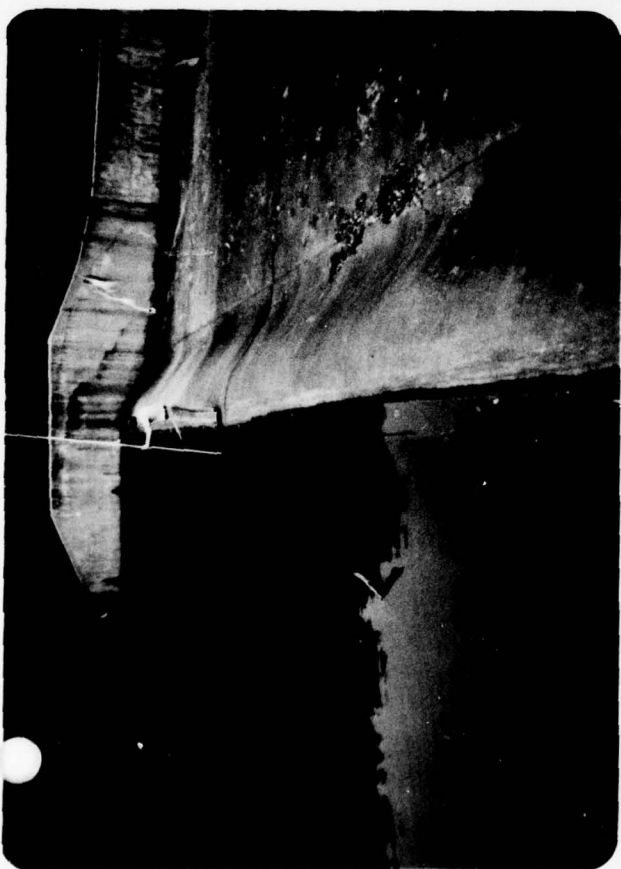
1. Spillway. The spillway, spillway abutments, discharge channel, and stilling basin all appeared in excellent condition except for some minor spalling of the weir crest and minor efflorescence.

b. Appurtenant Structures. Based on the visual inspection, the appurtenances appeared to be in good condition. No signs of concrete deterioration were observed on the portion of the vertical concrete riser which was visible. The fish catch basin had experienced some cracking in the asphalt liner but its general condition is good and its operation does not effect the structural integrity of the embankment. The spillway has experienced some concrete deterioration. Scaling was observed particularly on the left portion of the weir and some minor efflorescence was observed on the spillway wingwalls (see Photograph 5). The overall condition of the spillway is considered good.

PHOTOGRAPH 5 View of the ogee-shaped spillway crest. Note the efflorescence in the spillway wingwall.

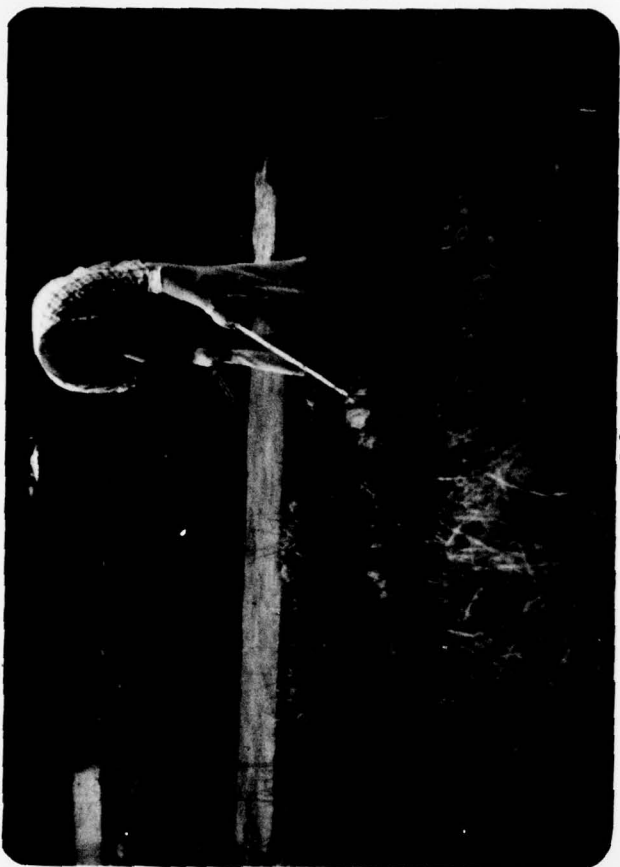
The discharge end of the outlet, including the asphalt-lined fish catch basin were in good condition. Some minor cracking has developed in the asphalt but the basin continues to function as designed. Seepage was noted along the right side of the fish catch basin (see Photographs 9 and 10 and Geology) and is probably related to natural ground water conditions.

PHOTOGRAPH 10 View of a small water filled cavity on the right side of fish catch basin. The area to the right of the basin was very swampy. The cavity may be one of many auger holes drilled during construction to delineate a gravel pocket encountered in the core trench excavation.

During the current inspection, an artesian flow was observed to be issuing from a 2-foot-deep hole adjacent the bituminous paving of the fish catch basin (see Photograph 10

and Figure 3). The observed discharge may be coincidental with auger hole number 23. This flow is most likely originating in the aforementioned pocket of permeable silty sand and gravel.
